# Manhole Inspection Summary

Manhole # S23Y\_\_022MH

**Location** Address: **2121 Hollins Ferry Rd**

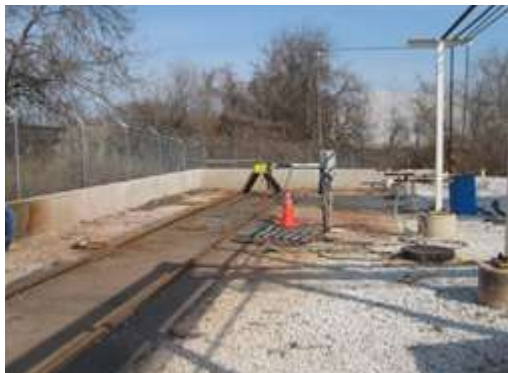
Location View

Leaf rear corner of Sherwin Williams property

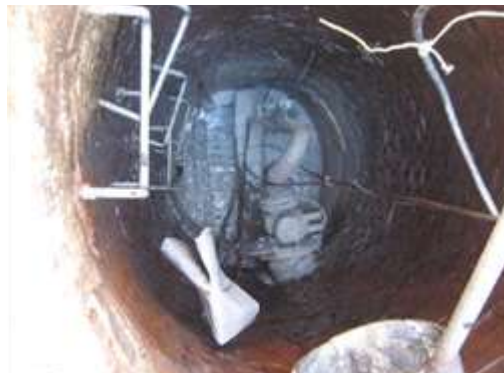
Top View

Flow meter in to MH

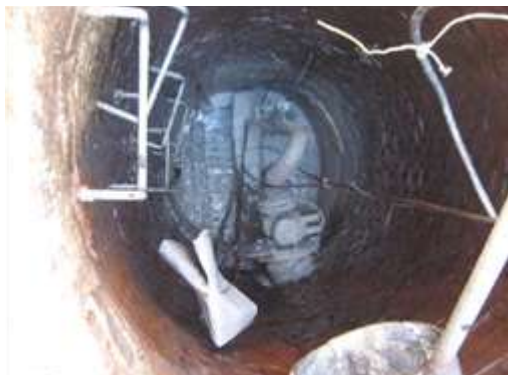
Misc.

Miscellaneous PVC pipe in at 6 under frame. Does not appear to be connected to lower pipe at 6.

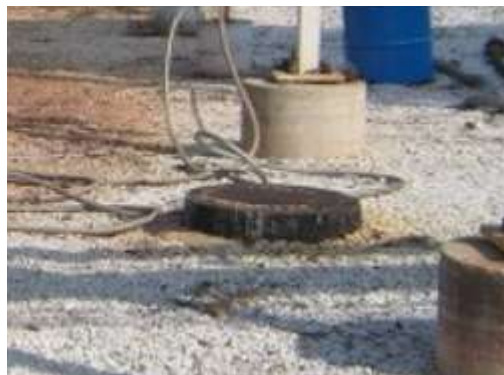
Miscellaneous

A/B GRADE 5 INCH

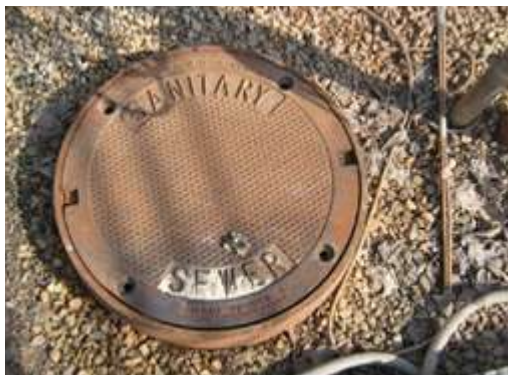
Miscellaneous

mh cover

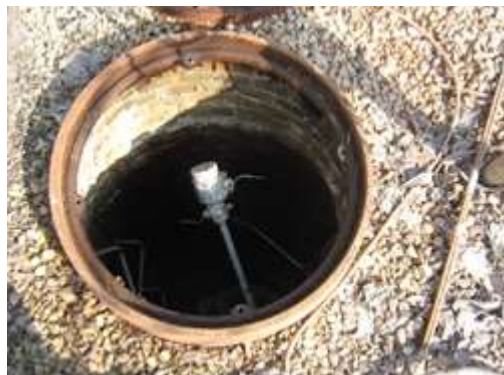
Miscellaneous

undetermined feature in center

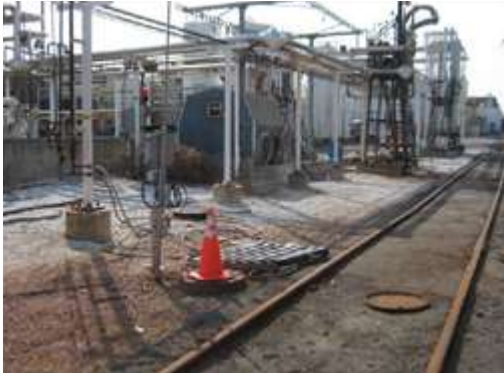
## Miscellaneous

Additional Location View

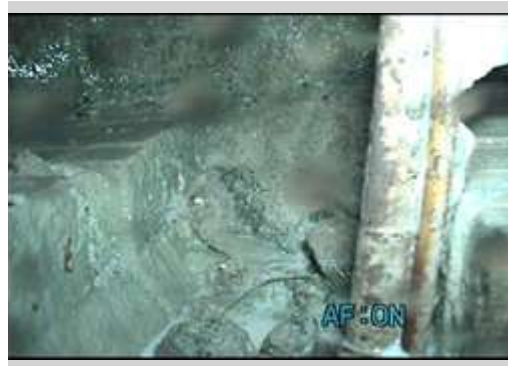
## Defect 1

channel debris

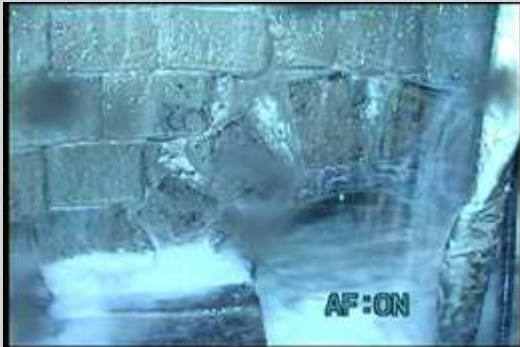
12 O'Clock Outflow

10 in. Circular Gravity Sewer  
Pipe Out @ 12 O'Clock

Pipe Height: **10.8** (in.) Rod and Bar (Angled)  
Pipe Material: **Unknown** ☐ Pipe Lined  
Invert Depth: **15.78** (ft.) Flow Characteristics: **Fast**  
Deposits: ☒ None ☐ Mud ☐ Sludge ☐ Debris ☐ Grease  
Silt Depth: **0** (in.) Deposits Extent:  
Infiltration: **None** Pipe Seal Cond: **Unknown**

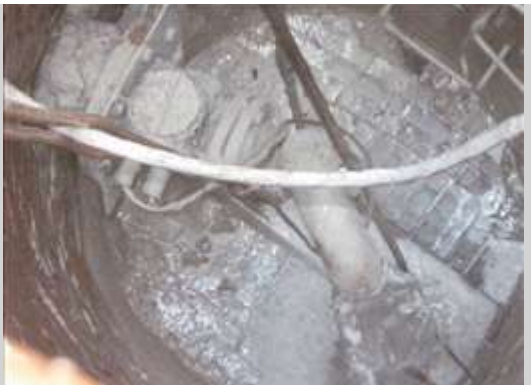
6 O'Clock Inflow

6 in. Circular Gravity Sewer  
Pipe In @ 6 O'Clock

Flow meter in

Pipe Height: **0** (in.) Direct  
Pipe Material: **PVC** ☐ Pipe Lined  
Invert Depth: **8.00** (ft.) Flow Characteristics: **Fast**  
Deposits: ☒ None ☐ Mud ☐ Sludge ☐ Debris ☐ Grease  
Silt Depth: **0** (in.) Deposits Extent:  
Infiltration: **None** Pipe Seal Cond: **Sound**
